Test Report # 30011300 Rev 0

Adiabatic Compression In Nitrogen Service

Scope: This test report contains test data on the effects of adiabatic compression in nitrogen service on AP3600 diaphragm valves with Vespel, Kynar, and PFA seats.

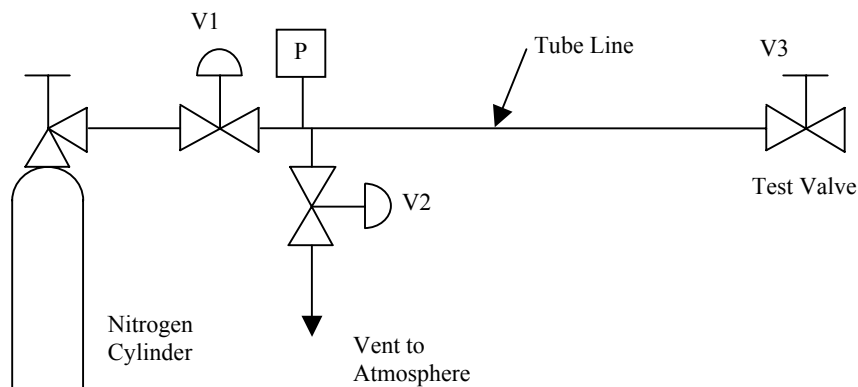
The test setup is shown in Figure 2. An AP3000 air actuated, diaphragm valve (V1) was connected directly to the cylinder outlet connection and used to rapidly pressurize the tube line at the inlet to an AP3600 manual, diaphragm valve (V3). An AP3000 air-actuated, diaphragm valve (V2) with a flow restrictor in the outlet was used to vent the tube line. A 0-3000 psig (0-207 barg) range transducer was used to monitor the tube line pressure. The transducer output was recorded using a data acquisition system at 240 samples per second. The tube line was 3/8 inch nominal size tube with .305 inch (7.7 mm) inside diameter. The tube line was 5 feet (1.5 m) long and installed at the inlet to the test valve. A new seat was installed in the test valve prior to the start of each test. Testing was performed using conditions that had resulted in failure of PCTFE seats – once a seat had failed, further testing on that seat material was stopped. For the tests with an across-the-seat leak, a notch was placed in the seat to create a leak path. A wire was pressed into the seat to create the notch. The wire was removed before installation of the diaphragms and actuator.

Figure 2. Adiabatic Compression Test Setup

The basic test procedure consisted of the below steps. Each seat was first evaluated with test valve V3 closed. The seat was then evaluated with test valve V3 partially open to achieve different flow rates. Finally, a notch was placed in the seat using a wire to create an across-the-seat leak in test valve V3 and the seat was evaluated with the test valve closed. Exact conditions for each test are described in the results section.

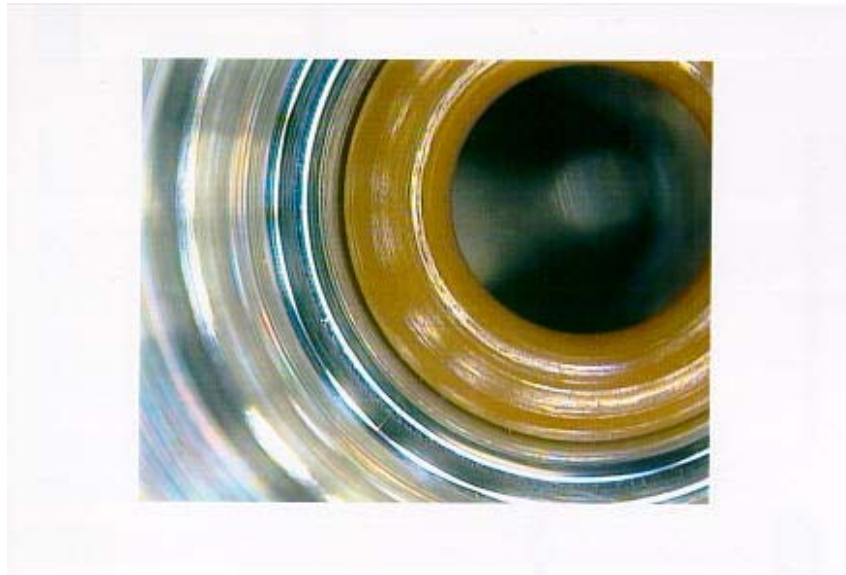
Figure 3. New Vespel seat before testing
(10X magnification)

A summary of the test results is shown in Table 1 for the Vespel seat tests, Table 2 for the Kynar seat test, and Table 3 for the PFA seat tests. The Vespel seat was not damaged during the test. Figure 3 shows a new Vespel valve seat prior to testing. Figure 4 shows the Vespel seat after valve test #V5. The Kynar seat showed melting and erosion that was similar to damaged PCTFE seats discussed in Report No. 30010000. Figure 5 shows a new Kynar valve seat prior to testing. Figure 6 shows a damaged Kynar valve seat after valve test #K2. Figure 7 shows a new PFA valve seat prior to testing. Figure 8 shows the PFA seat after valve test #P3. PFA seats are not used in high pressure AP Tech valves for a number of reasons. During this test, high pressure caused the seat to move upward out of the seat cavity as the valve was opened, effectively shutting off the flow. This movement prevented testing of the PFA seat when the valve was partially opened.

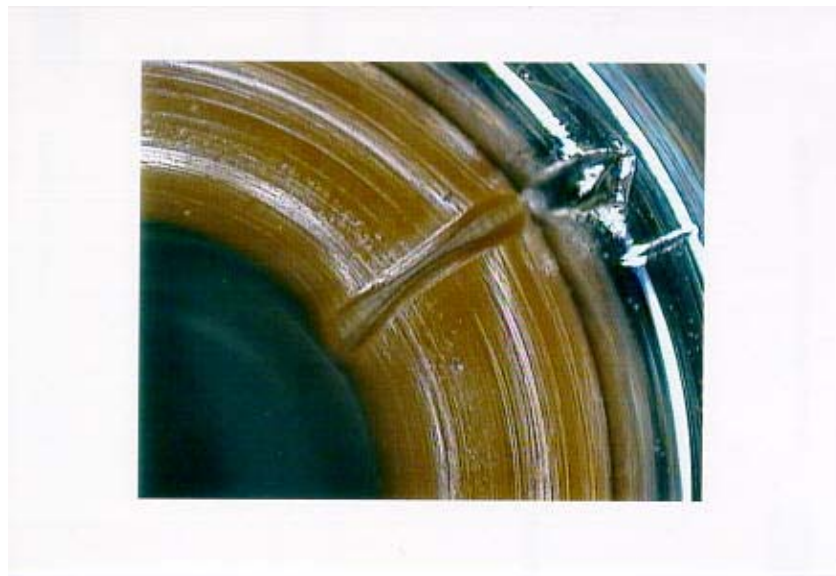
Figure 4. Vespel seat after Test #V5 (wire used to create across-the-seat leak)
(25X magnification)

Valve Test No.	Nominal Tube Size, inch	Flow Rate thru Test Valve V3 (at cylinder pressure), slm	Cylinder Pressure, psig	Cycles Performed	Fill Time, milliseconds	Seat Damage
Test valve V3 closed.						
V1	3/8	0	2414	10	117	No
Test valve V3 partially open.						
V2	3/8	60	2361	10	110	No
V3	3/8	150	2296	10	137	No
V4	3/8	350	2225	10	117	No
Test valve V3 closed but wire used to cause across-the-seat leak.						
V5	3/8	10	2130	10	125	No

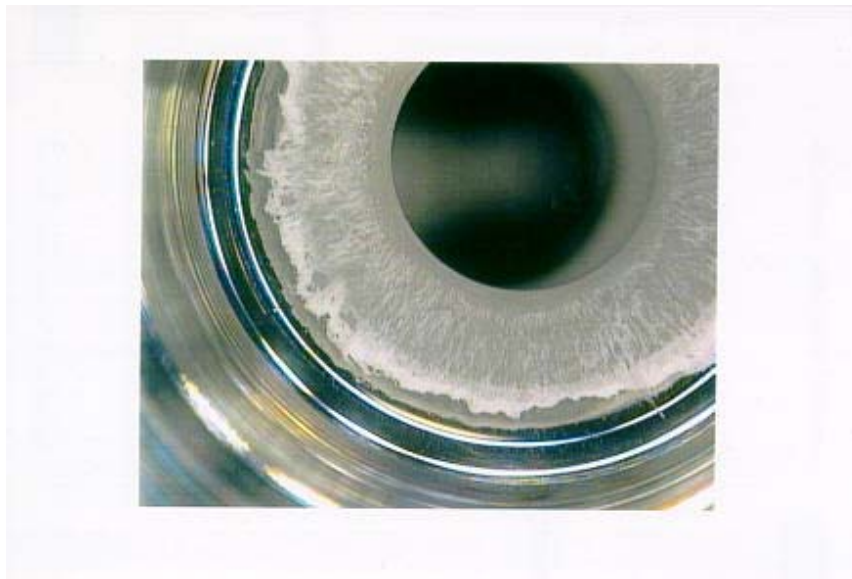
Figure 6. Kynar seat after Test #K2
(12X magnification)

Valve Test No.	Nominal Tube Size, inch	Flow Rate thru Test Valve V3 (at cylinder pressure), slm	Cylinder Pressure, psig	Cycles Performed	Fill Time, milliseconds	Seat Damage
Test valve V3 closed.						
K1	3/8	0	2110	10	132	No
Test valve V3 partially open.						
K2	3/8	150	2062	1	175	Yes

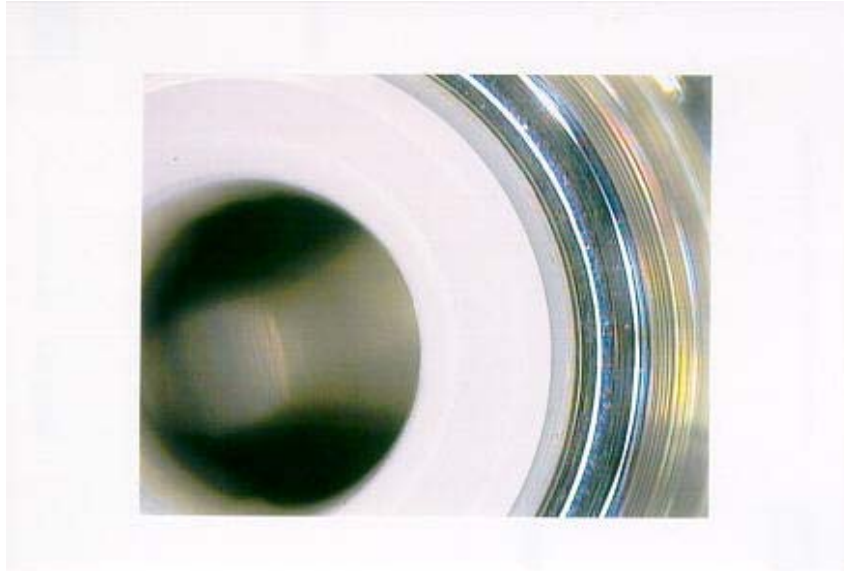
Figure 7. New PFA seat before testing
(15X magnification)

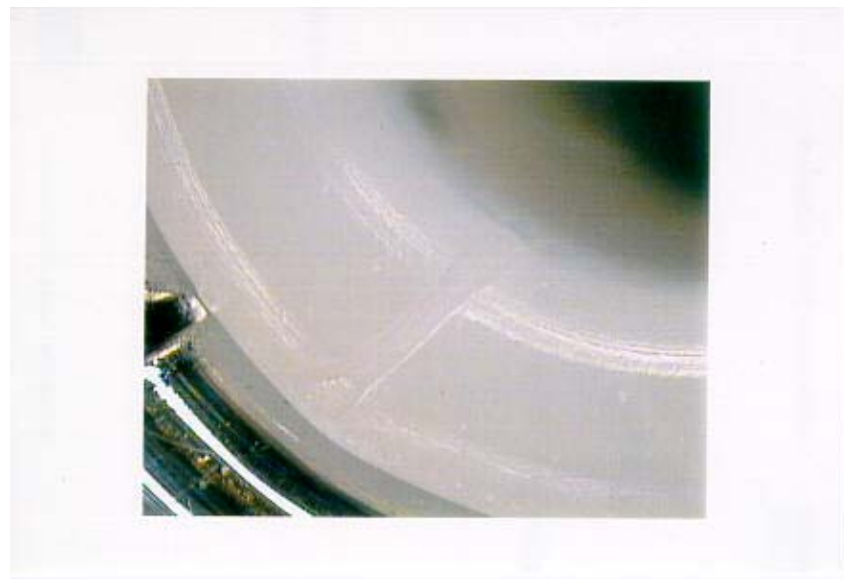
Figure 8. PFA seat after Test #P3 (wire used to create across-the-seat leak)
(30X magnification)

Valve Test No.	Nominal Tube Size, inch	Flow Rate thru Test Valve V3 (at cylinder pressure), slm	Cylinder Pressure, psig	Cycles Performed	Fill Time, milliseconds	Seat Damage
Test valve V3 closed.						
P1	3/8	0	2043	10	132	No
Test valve V3 partially open.						
P2	3/8	150	2003	*	*	*
Test valve V3 closed but wire used to cause across-the-seat leak.						
P3	3/8	3	2000	10	108	No
P4	3/8	7	1970	10	117	No
